INTRODUCTION

Marshfield Police Station and Emergency Operations Center is located on an approximately 1.9 acre plot at 1639 Ocean Street (Rt 139), Marshfield, Massachusetts (Image 1). The site is bounded to the north by Ocean Street, to the east by a residential neighborhood fronted on Carr Road and Woodlawn Circle, to the south by the Town DPW Garage and to the west by Parsonage Street. Ocean Street (Rt 139) is mixed residential and commercial, Parsonage Street is commercial/industrial and the other streets are residential.

This report is based on our visual observations during our site visits in the summer of 2015. During our site visit, we did not remove any permanent finishes or take measurements. Our understanding of the building is limited to the available drawings and our observations.

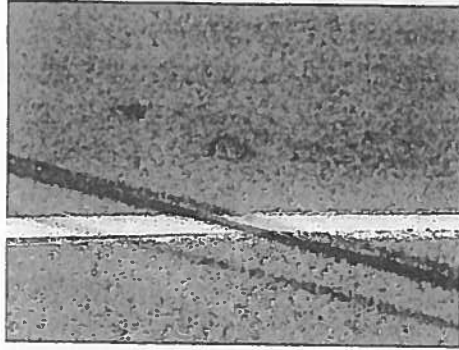
Image 5

There are no record plans that show the water service(s) entering the building; however a water valve was observed on site where the driveway entrance to the north of the building meets Parsonage Street (Image 5). There appears to be a water meter located on the eastern face of the building in the enclosed gravel space (Image 6). Water for the Police Station likely connects to a water main in Parsonage Street and flows into the building along the eastern face.

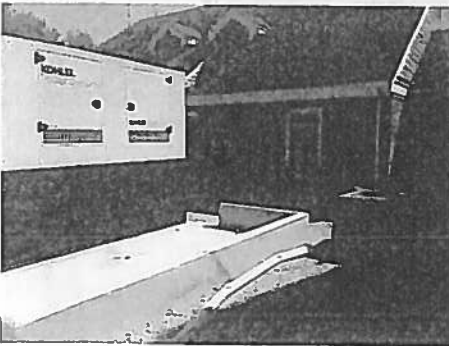
Image 8

There is no record information of the gas service through the site. A gas meter was observed along the eastern face of the building in the enclosed gravel utility area (image 7). There is also a generator to the east of the building in the enclosed gravel area (Image 8).

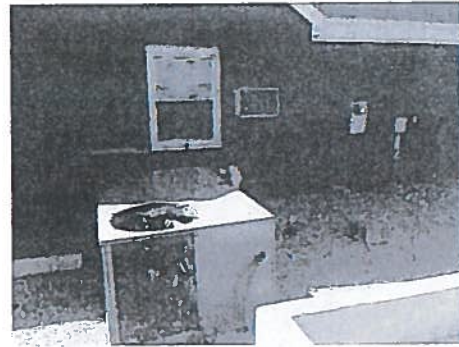
Image 9

There is no electrical information provided on the record plans. An electrical meter was observed on the eastern face of the building near the gas and water meters (Image 6). Air conditioning equipment was located along the western and eastern face of the building (Image 9, 10 and 11)

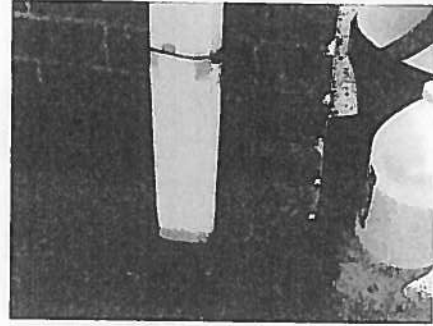
Image 1

- Chipping/cracking observed at outside corner of garage rm 104. Cracking continues up into brick veneer above for approximately 30". (Image 1)
- At the exterior stairwell, the stairwell brick wall intersects the older building brick. (Image 2, 3, 4) The source is not known however there are several areas that may be contributing factors: a) a gutter downspout (on the south side) is discharging water onto the door pad (and then toward the building, b) the extent and workmanship of step-flashing at roof to wall condition, c) the air conditioner drips condensation directly onto joint and extends down to foundation, d) inadequate thermal continuity at roof to wall transition causes build-up of ice dam and then freeze thaw action sends water behind shingles. Evidence of water intrusion is seen at the basement level of this stairwell. (Image 5)

- Provide a control joint at corner of building. Replace cracked bricks with new.
- Remove wood siding 6” up from roof on entire perimeter where asphalt shingle roof to siding occurs, and at dormers. Re-flash roof to wall transition with ice & water shield and metal flashing.
- Replace rotted wood and seal openings water tight.
- Re-paint/stain wood siding, trim and fascia.
- Ensure that Air Conditioning (AC) lines penetrations are adequately air and weather-sealed. Re-route lines to provide more direct route inside of building instead of draping along roof.
- At concrete pads in front of stairwell exterior doors, remove concrete pads and replace with frost-foundation wall and pad, such that water drains away from building

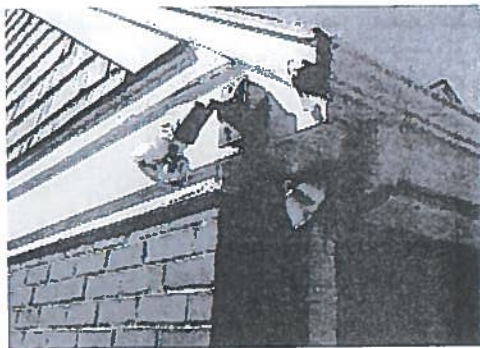
Image 7

particularly at roof to wall transitions, southern exposure, or areas where snow may stay for a long period of time. Having the wood siding so close to the roof below allows for accelerated deterioration of the siding. (ie. at shed dormer above the link between police station and the EOC, the shingles at the corner especially are in poor condition (Image 6). Paint/stain has faded from wood trim and fascia. Wood trim in at least one location had rotted, and large hole is visible (Image 7).

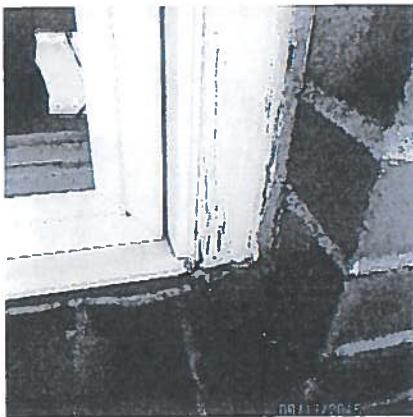
Image 8

- Original wood brick mould (exterior trim) on windows is not in good condition. (Image 8)

- Sealant around perimeter of windows is failing. (Image 8)
- Steel lintels spanning masonry opening at windows is rusting.

- Replace exterior wood brick mould/trim where deteriorated. Prep and paint where wood is not damaged.
- Remove and reinstall backer rod & sealant joint around windows
- Remove rust from lintels, prime and paint with industrial coatings.

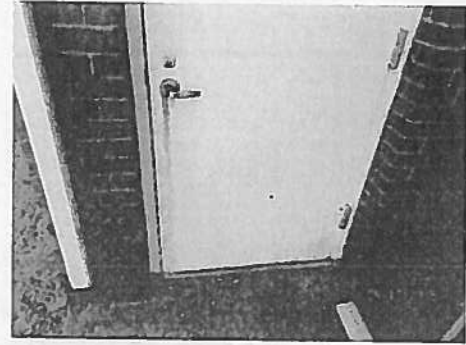
Image 9

- Main front entry door; gap observed above door head. (Door itself is fairly new and in good condition)
- Stairwell doors are in fair to good condition. South door is rusting at lockset and beginning to rust at bottom. (Image 9)
- Sallyport (garage) overhead door. Reportedly there have been numerous failures and repairs of the door. The other overhead doors are apparently not operated frequently.
- Frames at some exterior doors are rusting. (Image 10)

- Infill gap over main entry door to be weather tight.
- Replace doors and frames that exhibit rusting (estimate three locations).
- Replace overhead doors with thermally-efficient doors and operating assemblies.

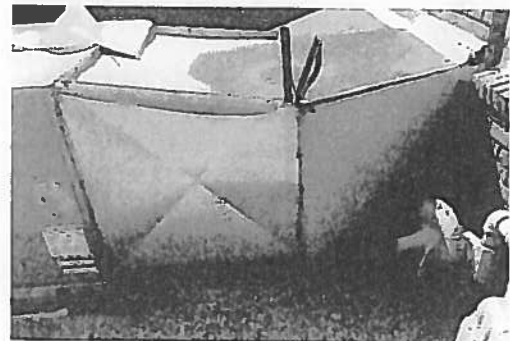
Image 11

at ground level, over the basement stair (Image 11, 12). The duct is significantly rusted, not insulated, the flashing has failed between the wall and the duct and a 5" gap between the duct and shed roof over the basement stairway allows water and snow to accumulate up against the shed roof. We believe this is source of water entering basement (see Interior Walls and Partitions).

- The exterior duct from the AC condenser unit to east of police station should be removed completely and reinstalled as an insulated duct with proper flashings at wall penetration (approx. 8'Lx 4' w x3' h).
- In this type of construction, typically systems using gable end vents do not perform as well as those using ridge vents. See Roof recommendations.

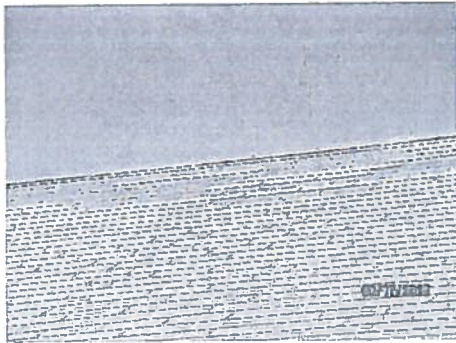
Image 14

- Reportedly there was a roof leak above the Chief's Office last year which resulted in the need to remove and replace the ceiling.
- The EOC roof is older than the police station roof and is in fair condition. There are areas where it is apparent that patching has occurred. (Image 14, 15)

- Monitor EOC roof and plan to re-roof within five years. Relocate insulation to the roof plane by providing a vented composite insulation board, and using spray-foam insulation at gable end walls and roof to wall transitions. This will allow for a continuous thermal envelope that is not affected by any HVAC, plumbing or electrical cabling work done in the attic.

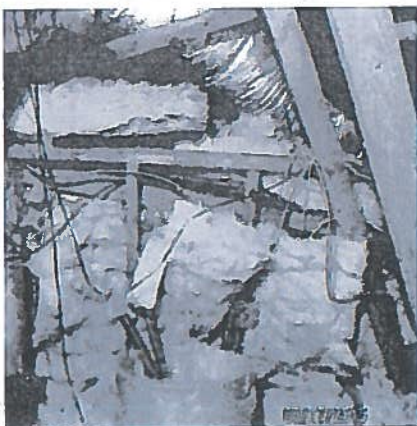
Image 16

- Inadequate thickness and placement of insulation. Insulation has been disturbed for running cabling and HVAC related work, creating breaks in the thermal envelope. (Image 16, 17)

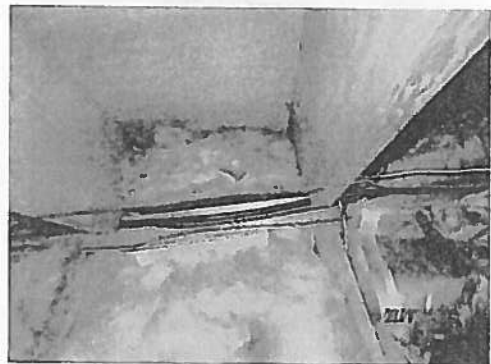
Image 18

- Lack of soffit vents (Image 18) Small gable end louver vents in the EOC appear undersized resulting in not enough air to adequately vent the roof.
- Mechanical ducts ineffectively wrapped with fiberglass batt insulation (Image 19)
- Inadequate thickness of insulation (R-11 at kneewall), and numerous gaps. While a vapor barrier (poly-sheet) was visible at corridor wall, none was visible between insulation and ceiling (Image 20). Several areas were noted where insulation was missing or moved.
- Evidence of water staining on floor of air handling unit
- Evidence of water intrusion around gable end vents (Image 21).

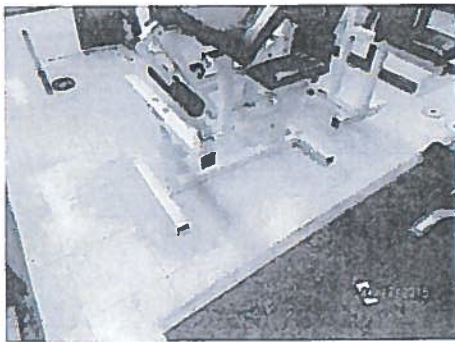
Image 23

- Dispatch/Communications Center has a relatively new anti-static carpeted floor.
- VCT on second floor is in relatively poor condition.
- There is a hump in the floor at the top of the west stairs apparently at the junction between 1958 and 1978 construction. (Image 23)

- Replace 2nd floor VCT floors with flocked flooring.
- Reconstruct stair landing to eliminate hump.
- Prep and add seamless resilient flooring or flocked flooring to evidence storage areas adjacent to garage.
- Remove VCT from stair treads and install raised rubber treads.
- Infill gap between wall and stairs.
- Replace VCT in weight room with rubber flooring designed for weight rooms. Include topical moisture mitigation. Prior to beginning work, address sources of water leaking.
- Prep basement data equipment room floor and install anti-static resilient flooring.
- Prep basement room floors and install industrial coating.

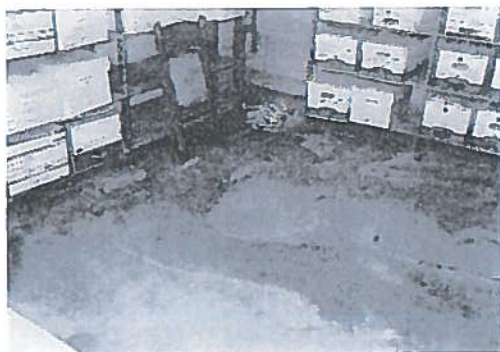
Image 24

- VCT floor at weight room area in basement is shows signs of water leaking onto floor. (Image 23)
- Data equipment room in basement is bare concrete.
- Records storage and other rooms in basement with bare concrete floors. (Image 24)

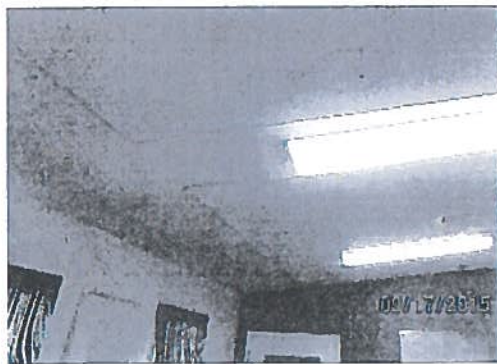
Image 29

- Second floor ceiling at Chief's Office was damaged in 2014 by water infiltration through roof and was recently repaired.
- Some basement ceilings have penetrations for various electrical conduits and wiring which have not been infilled. The ceiling is damaged in numerous areas (Image 27, 28). The ceiling is very tight to the structure
- Acoustical Ceiling Tile (ACT) ceilings in the EOC room have some water damage in various locations (presumably from water leaking through roof) (Image 29)

- Replace damaged ceiling tile and GWB assemblies in the EOC room, after completion of attic and roof repairs and modifications. (estimate 100 sf)

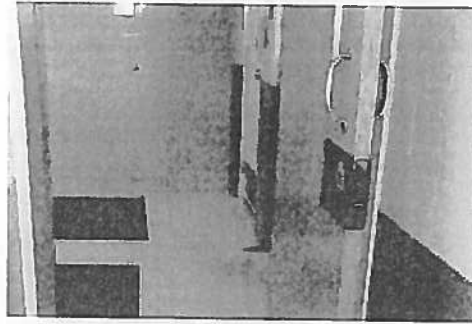
Image 30

- Doors and hardware in prisoner processing area and cells area indicate makeshift modifications to attempt to meet security needs. (Image 30) Note that egress/exit doors may not be controlled via combination locks or other mechanisms which would prevent egress in case of emergency.
- Basement door to east stairwell has damaged door frame at lock strike area (Image 31)
- Lack of door closers with proper hold-open function results in contrived solutions. (Image 32)

- Replace hollow metal door frame at east stairwell.
- Replace closers at three locations with closers that have hold-open feature.
- Replace doors and hardware throughout prisoner processing area, cell doors, evidence rooms as well as basement door, utilizing an integrated building keycard or similar electronic access & security/alarm system that aligns with the operational needs of the department.

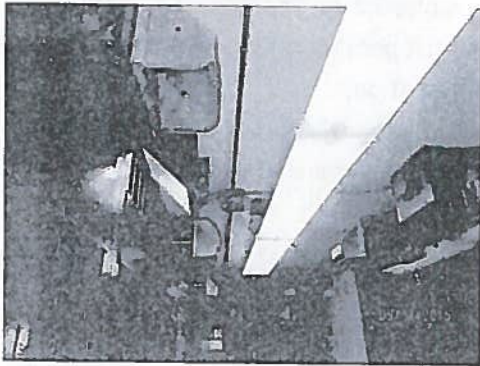
Image 39

- Lack of adequate ventilation at cells (Image 39, 40)

- Refer to Mechanical Report for recommendations on ventilation system upgrades.
- Replace door frame, door and hardware at stairwell and storage rooms with fire-rated type.
- Renovate approximately 800 sf of space to provide proper and secure storage of confiscated evidence, firearms, drugs, etc. as well as archival storage.
- Widen admin 3' corridor to be 4' minimum.
- Renovate intake processing area to allow for safe/secure passage of people in custody (estimate 600 sf area).
- Renovate cell area to provide safe and segregated spaces meeting current industry standards (estimate 500 sf area).
- Replace outdated equipment in intake processing area.

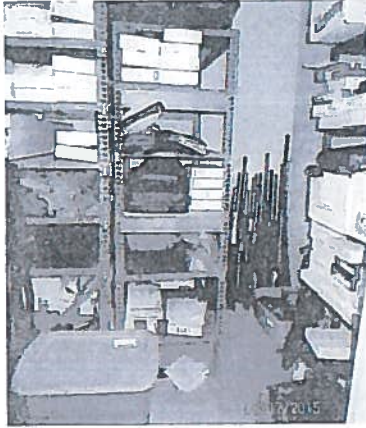
Image 41

- Lack of proper wall and door ratings between spaces. Example, stairs connecting three occupied floors.
- Storage of evidence, drugs and firearms where lack of ventilation, adequate space, storage racks/shelving/secure cabinets, lighting, or ventilation makes these potentially unsafe/inadequate spaces (Image 41).

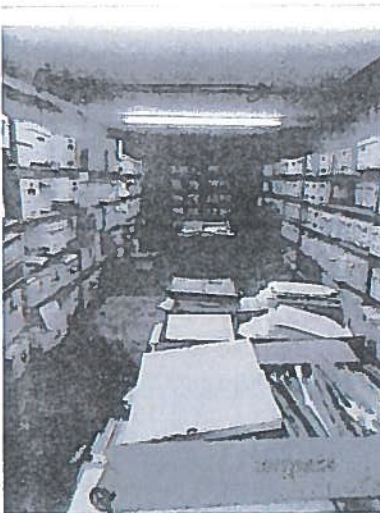
Image 43

- Archival records storage is located in the basement with inadequate ventilation and damp conditions (Image 43).

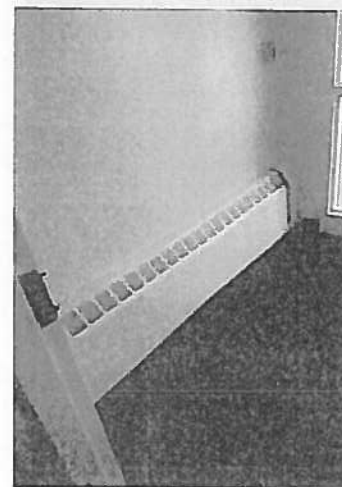
Image 3 - Hot Water Baseboard Fin Tube Radiation Heating

The Police Station is heated by a combination of a hot water coils in the air handling unit, fin tube radiation and unit heaters. The unit heaters and associated piping appears to be originally installed equipment. The fin tube radiation heating equipment is generally in fair condition. (Image 3)

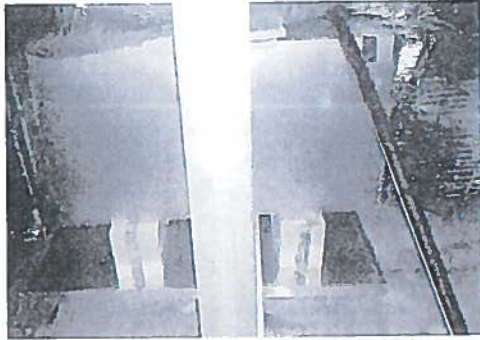
Image 4 – Indoor Air Handling Unit

Split system indoor air handling units with DX outdoor air cooled condensing units provide Air conditioning in the Station. Indoor air handling units were manufactured by Goodman Air Conditioning model ARUF48D14AC5. (Image 4) Outdoor air cooled condensing units manufacturers but appear to be from the same renovation of 1999 to 2000. Outdoor condensing unit manufactured by Rheem model RAKA-048JAZ6. (Image 5) Equipment is approaching the end of its service life expectancy.

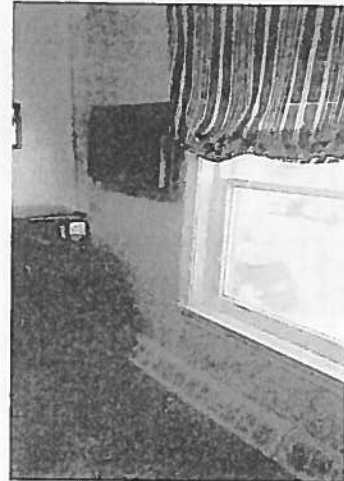
Image 7 – Wall Air Conditioner

Through wall air conditioners have been added in many spaces throughout the Police station as supplemental air conditioning. (Image 7)

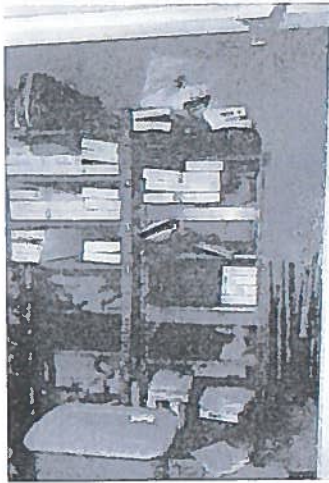
Image 11 – Confiscated Storage

The single Garage is heated with a hot water unit heater. There is no vehicle exhaust system in this space. The double garage has been converted for an exercise space in the open area and confiscated storage in the lockable storage goods. There is not adequate exhaust or ventilation in these spaces. Storage areas are heated, but have no air conditioning. (Image 11)

- Exhaust/ventilation upgrades in confiscated storage rooms.
- Controls: Installed new direct digital control, energy management system that all replacement and existing to remain HVAC systems can be controlled by for improved thermal comfort control and energy efficient system operation.

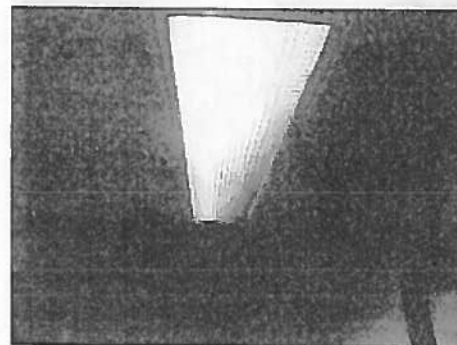
Image 4 - Lobby Lighting

The Main Lobby has 1x4 surface mounted parabolic lensed fixtures with T8 lens. (Image 4)

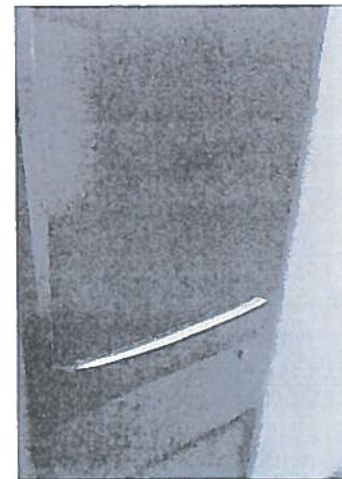
Image 3 – Drinking Fountain

The drinking fountains are stainless steel, recessed units which may not meet current accessibility codes. (Image 3)
