INTRODUCTION

Marshfield Police Station and Emergency Operations Center is located on an approximately 1.9 acre plot at 1639 Ocean Street (Rt 139), Marshfield, Massachusetts (Image 1). The site is bounded to the north by Ocean Street, to the east by a residential neighborhood fronted on Carr Road and Woodlawn Circle, to the south by the Town DPW Garage and to the west by Parsonage Street. Ocean Street (Rt 139) is mixed residential and commercial, Parsonage Street is commercial/industrial and the other streets are residential.

This report is based on our visual observations during our site visits in the summer of 2015. During our site visit, we did not remove any permanent finishes or take measurements. Our understanding of the building is limited to the available drawings and our observations.

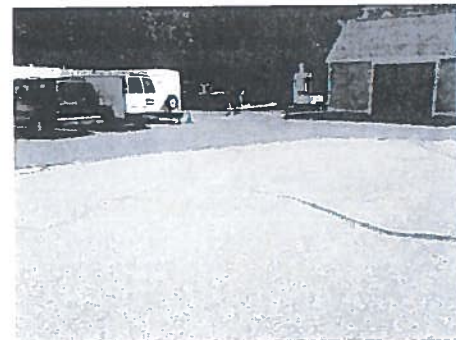
Image 4

One sewer manhole was observed on site towards the south end of the parking lot to the south of the building (Image 4). There was an unmarked manhole immediately to the south of the building which may be a sewer manhole (Image 3). No record plans show this manhole.

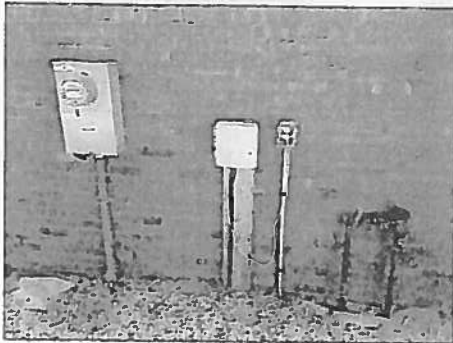
Image 6

There is no electrical information provided on the record plans. An electrical meter was observed on the eastern face of the building near the gas and water meters (Image 6). Air conditioning equipment was located along the western and eastern face of the building (Image 9, 10 and 11)

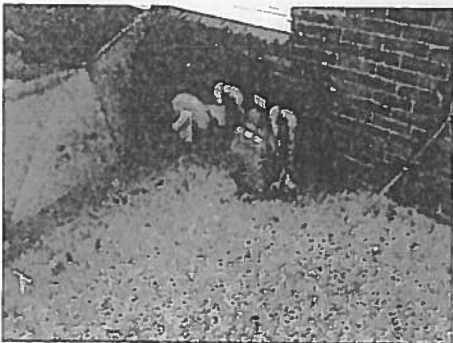
Image 7

There is no record information of the gas service through the site. A gas meter was observed along the eastern face of the building in the enclosed gravel utility area (image 7). There is also a generator to the east of the building in the enclosed gravel area (Image 8).

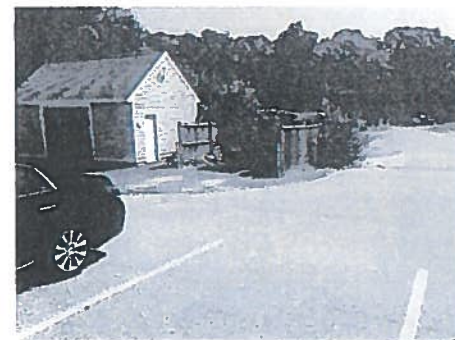
Image 12

The asphalt pavement within the site is in generally good to fair condition with areas of minimal cracking and degradation (Image 12). The walkways onsite are asphalt or concrete and are generally in good to fair condition. The walkways are not for public access and are only located to the south of the building. Access to the front of the building is from the parking spots in the driveway and across the driveway to the main entrance. There is concrete curb along the parking area of the driveway to the north of the building. The curb is in good condition. There is concrete curbing located along the south side of the building along a walkway. The curb is in good condition with minimal areas of degradation (Image 11).

- Mill and overlay sections of pavement where cracking/degradation has occurred.
- Replace curb where it has been damaged.
- Provide ADA access from parking spaces to the north of the building to the main building entrance.

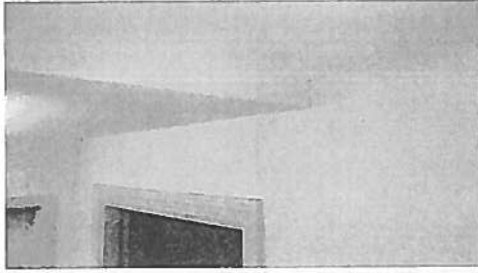
Image 5

Minor cracks in the drywall finishes were observed in a few locations throughout the building (Image 5 and 6). Exposed wood framing was observed and appeared to be in good condition (Image 7 and 8). Reports of water leaking in the chief's office were described but not observed. The floor finish appeared to be peeling and cracking. **It appears that a significant amount of moisture is present in the basement and has caused some minor damage to the finishes.** It appears that an assessment of the floor structure supporting the servers on the second floor was performed in the past. The previous engineer's recommendation was to install steel plates to spread the load.

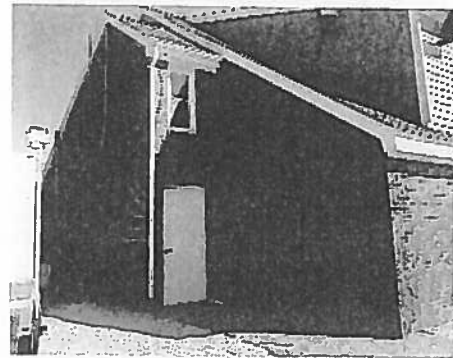
Image 2

- Chipping/cracking observed at outside corner of garage rm 104. Cracking continues up into brick veneer above for approximately 30". (Image 1)
- At the exterior stairwell, the stairwell brick wall intersects the older building brick. (Image 2, 3, 4) The source is not known however there are several areas that may be contributing factors: a) a gutter downspout (on the south side) is discharging water onto the door pad (and then toward the building, b) the extent and workmanship of step-flashing at roof to wall condition, c) the air conditioner drips condensation directly onto joint and extends down to foundation, d) inadequate thermal continuity at roof to wall transition causes build-up of ice dam and then freeze thaw action sends water behind shingles. Evidence of water intrusion is seen at the basement level of this stairwell. (Image 5)

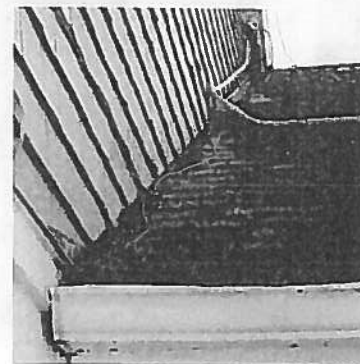
Image 4

- Condensate (for AC units) and power lines are penetrating sidewall and laying on roof. (Image 4, top). From inside the attic, daylight is visible around the opening where the refrigerant line passes. Similar condition is noted at louver on south side of building.

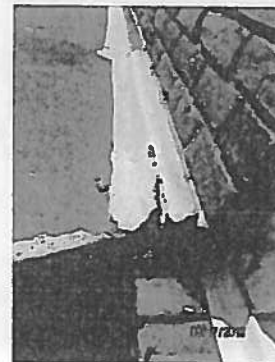
Image 12

at ground level, over the basement stair (Image 11, 12). The duct is significantly rusted, not insulated, the flashing has failed between the wall and the duct and a 5" gap between the duct and shed roof over the basement stairway allows water and snow to accumulate up against the shed roof. We believe this is source of water entering basement (see Interior Walls and Partitions).

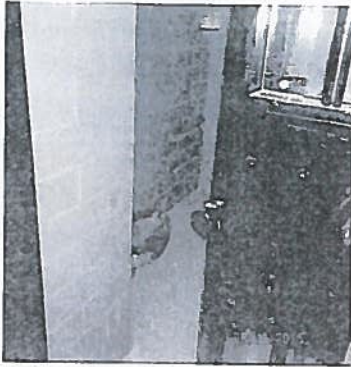
Image 38

- Door threshold at south door alongside garage doors is approx. 10" above grade.
- There are numerous barriers to an accessible route for people that are taken into custody and in the processing area (i.e. door knobs, counter height, passage widths, lack of handicap accessible toilet) (image 37, 38).

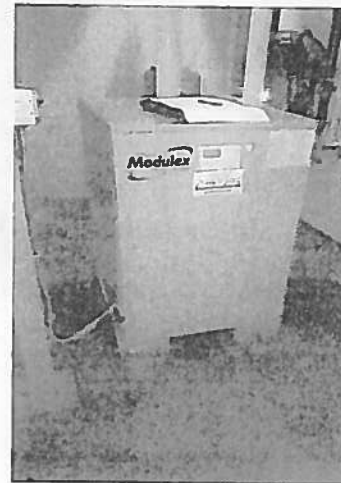
The building has many spaces that cannot maintain adequate space temperature. The entry lobby of the Station has no heat source and becomes very cold in the winter. Heating pipes in the stairwell freeze on an annual basis. Overall the Heating system appears undersized for the building and distribution in the building does not appear adequate to satisfy the building heat loss.

Image 1 - Boiler

- Heating System: Although the boiler has recently been converted to a high efficiency condensing boiler, the boiler plant appears undersized to satisfy the total building heat loss demand. Provide a second high efficiency condensing boiler to add to the system. The second boiler would provide built in redundancy minimizing the building losing its heat source and satisfy the overall heat loss demand of the building.

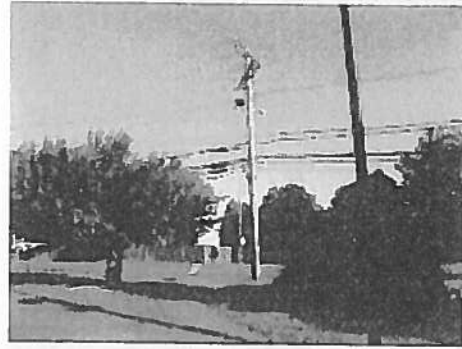
Image 1- Pole Mounted Overhead Service

The primary service runs overhead along Ocean Street where it transitions to underground and runs to a meter on exterior of the building and to a 400 Ampere, 120/208V, 3Ø, 4W main distribution panel. The main breaker is a 400 Amp frame. The equipment was manufactured by FPE. The distribution section is rated at 400 Amps and consists of breakers feeding other panels throughout the building. (Image 1, Image 2)

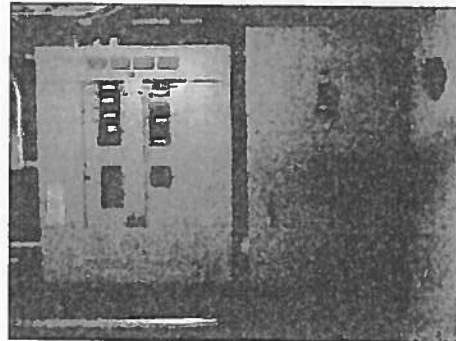
Image 2 - Main Switchboard

The FPE switchgear is in poor condition and should be replaced

- Provide a new 800 Ampere, 120/208V, 3 Phase, 4 Wire Service to replace existing service. Replace all FPE switchgear with new and backfeed existing feeders and circuitry.
- Provide occupancy sensors in all spaces to conserve energy.
- Replace exterior building mounted and pole mounted lights with energy efficient, long-life LED sources that are dark sky compliant.
- Add emergency lighting to exterior doors by replacing existing HID fixtures with instant-on LED fixtures.
- Add fuel monitor annunciator.
- Replace existing fire alarm system with an addressable system with full coverage.
- Replace interior lighting by replacing existing fixtures with LED fixtures.
- Provide additional receptacles and circuitry throughout the facility to suit the needs of the Police Station.

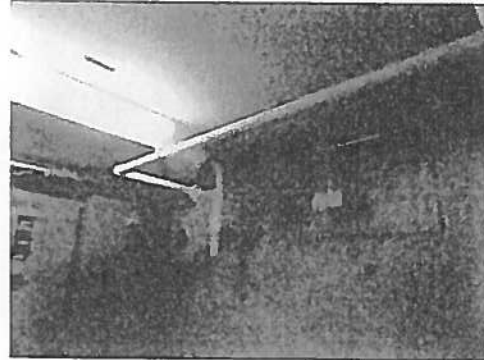
Image 3 - Gas Piping in Electric Room

The Main Electric Room has gas and heating pipes running through it. (Image 3)

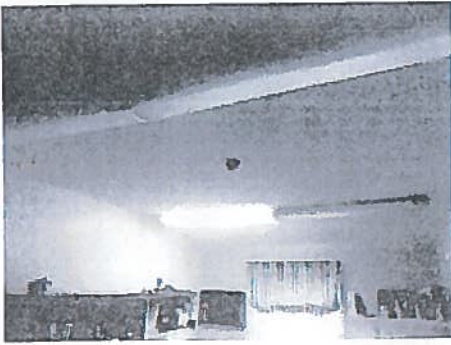
Image 5 – Office Lighting

Typical Offices have 1x4 surface wraparound fixtures with acrylic lens controlled with two (2) switches. There are no occupancy sensors in the building. (Image 5)

The lighting is generally in poor condition with spaces not well lit.

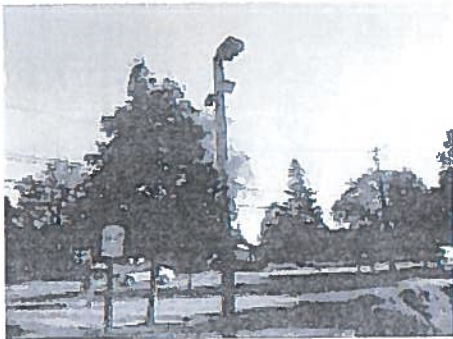
Image 6 – Pole Lighting with Floods

Exterior lighting consists of flood lights with metal halide lamps mounted from the building and pole mounted HID fixtures with floods. (Image 6, Image 7)

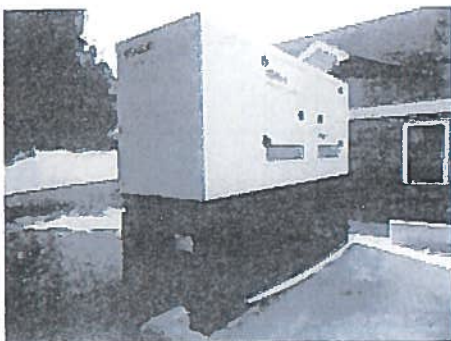
Image 8 – Exterior Diesel Generator

The facility has an exterior diesel generator with an integral tank with alarms. The generator is rated at 125 KW 120/208V, 3Ø, 4W manufactured by Kohler. (Image 8)

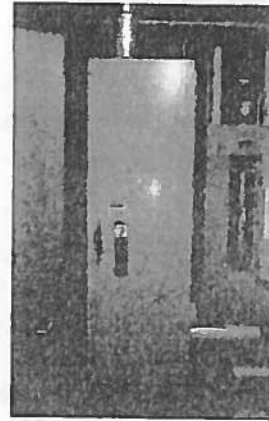
Image 9 – Automatic Transfer Switch

There is one (1) transfer switch manufactured by Russ Electric. (Image 9)

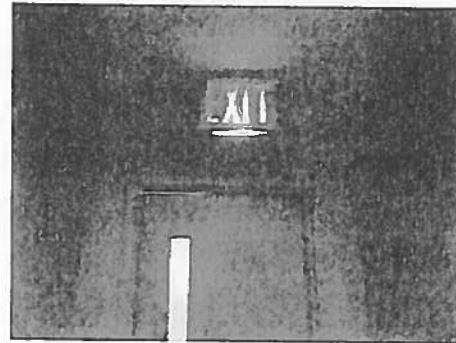
Image 10 – Exit Sign

Exit signs are of the cast aluminum type with fluorescent lamps. (Image 10)

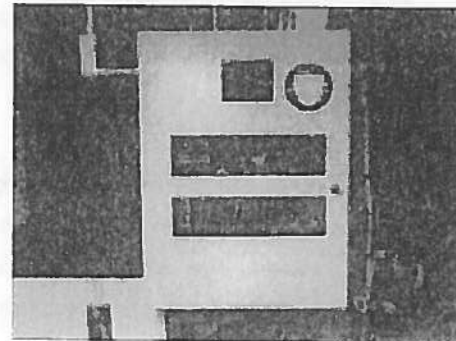
Image 11 – Fire Alarm Control Panel

The facility's fire alarm system consists of a FCI 12 zone non-addressable panel. (Image 11)

Fire alarm system devices appear to have poor coverage.

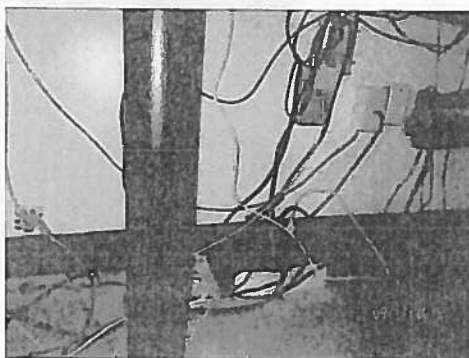
Image 13 – Excess extension cords

Numerous extension cords and power strips were noted due to the lack of receptacles located near the equipment loads (Image 13). The use of extension cords in place of permanent wiring is a safety hazard and a code violation.

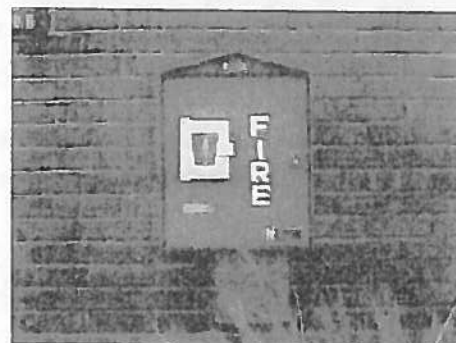
Image 12 – Master Box

The form of alarm transmission is via a master box. (Image 12)

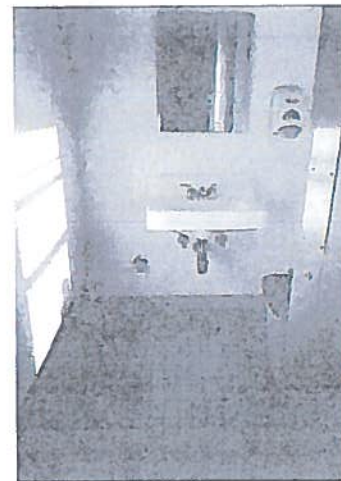
Image 2 – Wall hung Lavatory

Lavatories are wall hung or counter mounted vitreous china. The lavatories have hot and cold water, dual handle faucets. Some fixtures have been retrofitted with mixing metering faucets with push button handles. (Image 2)

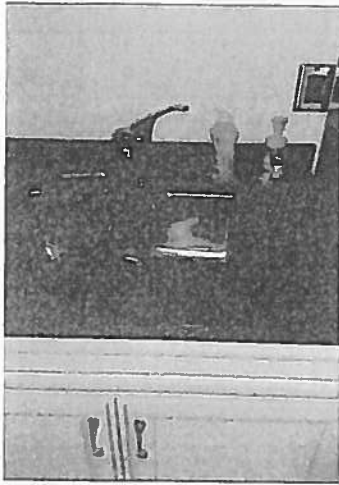
Image 4 – Kitchen Sink

The Kitchen sink is stainless steel, drop-in type with a hot and cold water faucet and vegetable spray. (Image 4)

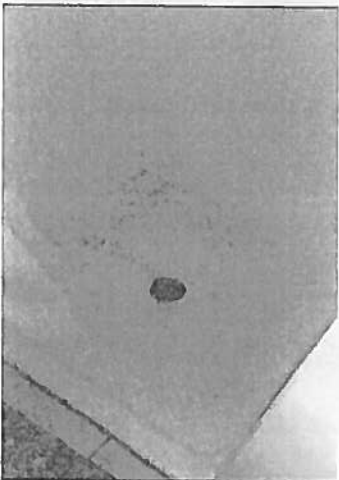
Image 5 – Shower Base

The showers are acrylic enclosures with molded stone bases. The shower mixing valves are standard thermostatic and pressure balancing units with standard 2.5 gallon per minute shower heads. (Image 5)

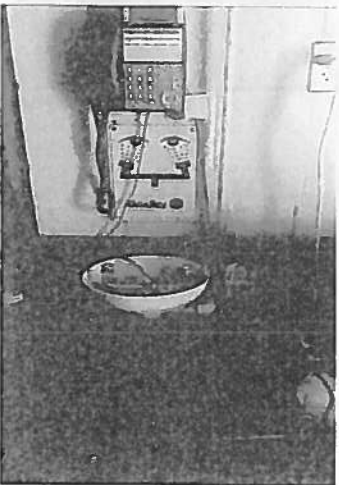
Image 6 – Emergency Eyewash

There is an emergency eyewash in the Garage with is piped with cold water only. Current ANSI standards require tempered water to emergency fixtures. (Image 6)

- Provide new high efficiency low-flow plumbing fixtures throughout.
- Provide mixing valve to deliver tempered water to emergency eyewash.
- Video tape all buried drainage piping and repair/replace sections of pipe and/or any leaks.
- Replace domestic water heater to serve the plumbing fixtures requiring hot water. Provide thermostatic mixing valve and expansion tank.

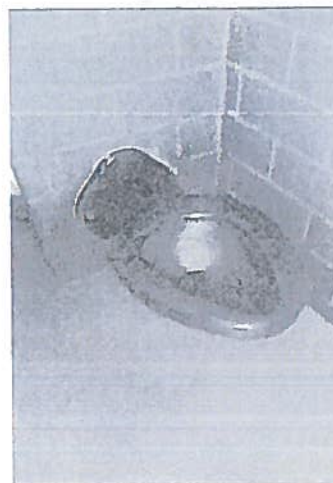
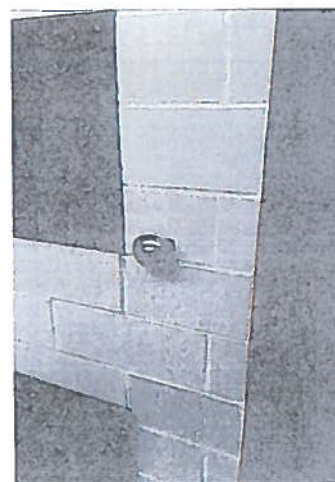
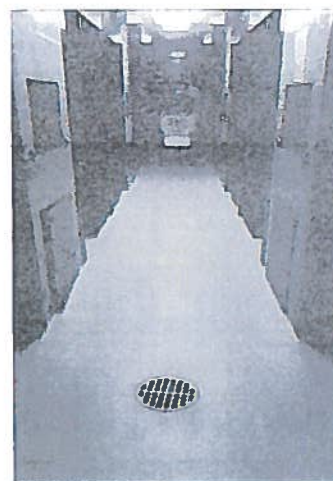
Penal fixtures are wall mounted, stainless steel water closets with remote pushbutton flush valves located outside of each of the cells. There is a service sink in the passage between cells for handwashing purposes. (Images 7, 8, 9)

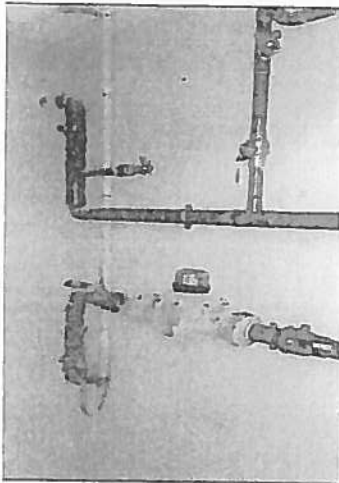
Image 10 – Water Meter

The domestic water service is located in the Storage Room in the Basement. The service is 2" in size and includes a water meter. The main domestic cold-water distribution is 2" in size. (Image 10)

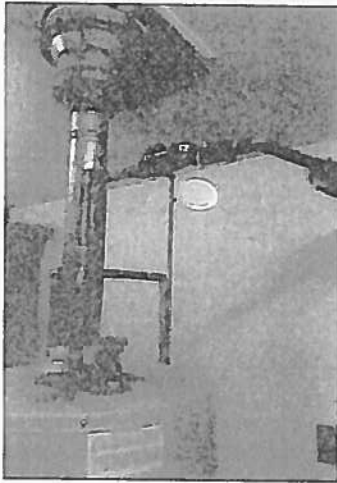
Image 11 – Water Heater

The water heater is in good condition, but is inefficient. (Image 11)

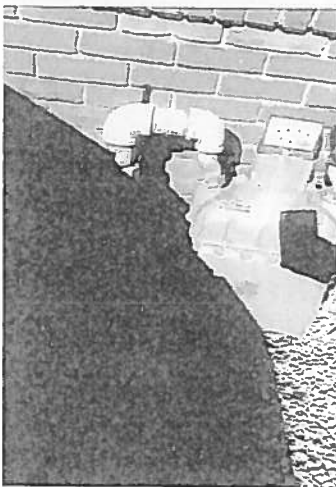
Image 12 – Gas Meter

The gas service for the building is an elevated pressure line with a regulator, gas meter for the building. Natural gas supplies the heating equipment, Kitchen cooking equipment and domestic water heater. (Image 12)
